HYDROGEOLOGICAL INVESTIGATIONS IN
THE PAMPA OF ARGENTINA

Dr. Dieter BANNERT

November 1974

Type III Report

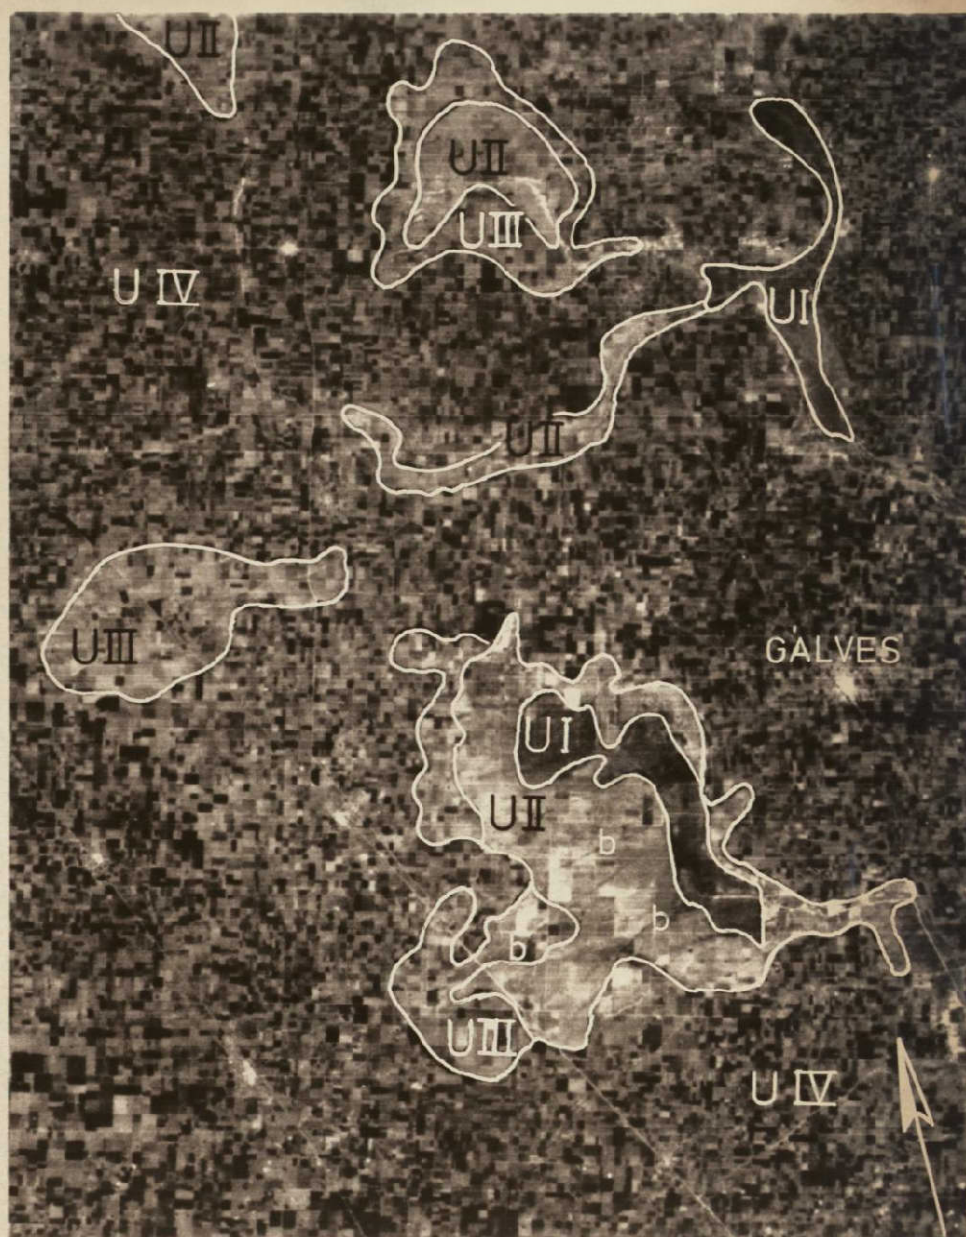
Fig.: 2

Areas of differing ground water salinity 75km SW of Santa Fé

UI – UIV show different salinity of ground water
b = Bajos

Regions with different grey tones on the imagery represent different types and density of vegetation. This is closely related to the depth to ground water. Generally, ground water mineralisation and the salt content in the soil, increases due to the influence of evapotranspiration with decreasing depth to ground water. High ground water salinity and soil salinity lead to unfavourable growth conditions for plants with high chlorophyll content. These regions appear dark in channel 7 and light in channel 5 (fig. 2).

The identification of different units was carried out using channel 5 images which provided the best contrast for this type of interpretation (fig. 2).

Unit I (UI)

Image indication: Very dark areas caused by high soil moisture, sparsely cultivated; e.g.: Borders of the Rio Paraná affluents and lowlands in the North of lagoon Mar Chiquita. (See also: Terraces of the Rio Paraná, LT and UT, in Fig. 5.)

Hydrogeological conditions: Depth to ground water less than 0,5 m; high ground water salinity.

Image indication: Light areas with indistinct field pattern, e.g.: Surroundings of Rio Paraná affluents.

Hydrogeological conditions: Depth to ground water up to about 5 m; high ground water salinity.

Image indication: Light areas with distinct field pattern.

Hydrogeological conditions: Depth to ground water up to about 10 m, medium salinity of ground water.

Image Indication: Dark areas with distinct field pattern.

Depth to ground water more than 10 m. Medium to low
salinity of ground water.

Because of similar phenology, irrigated farmland (fig. 6, unit A₁) cannot be distinguished from non irrigated farmland of UIV (fig. 2).

"Bajo" is an Argentinian term to describe elongated flat depressions with little or no surface drainage. In space imagery they appear as sharply defined strips (b in fig. 2). They run more or less straight in an ENE-WSW direction, are between 100 and 200 m wide and are spaced at relatively even distances of approximately 2 km apart.

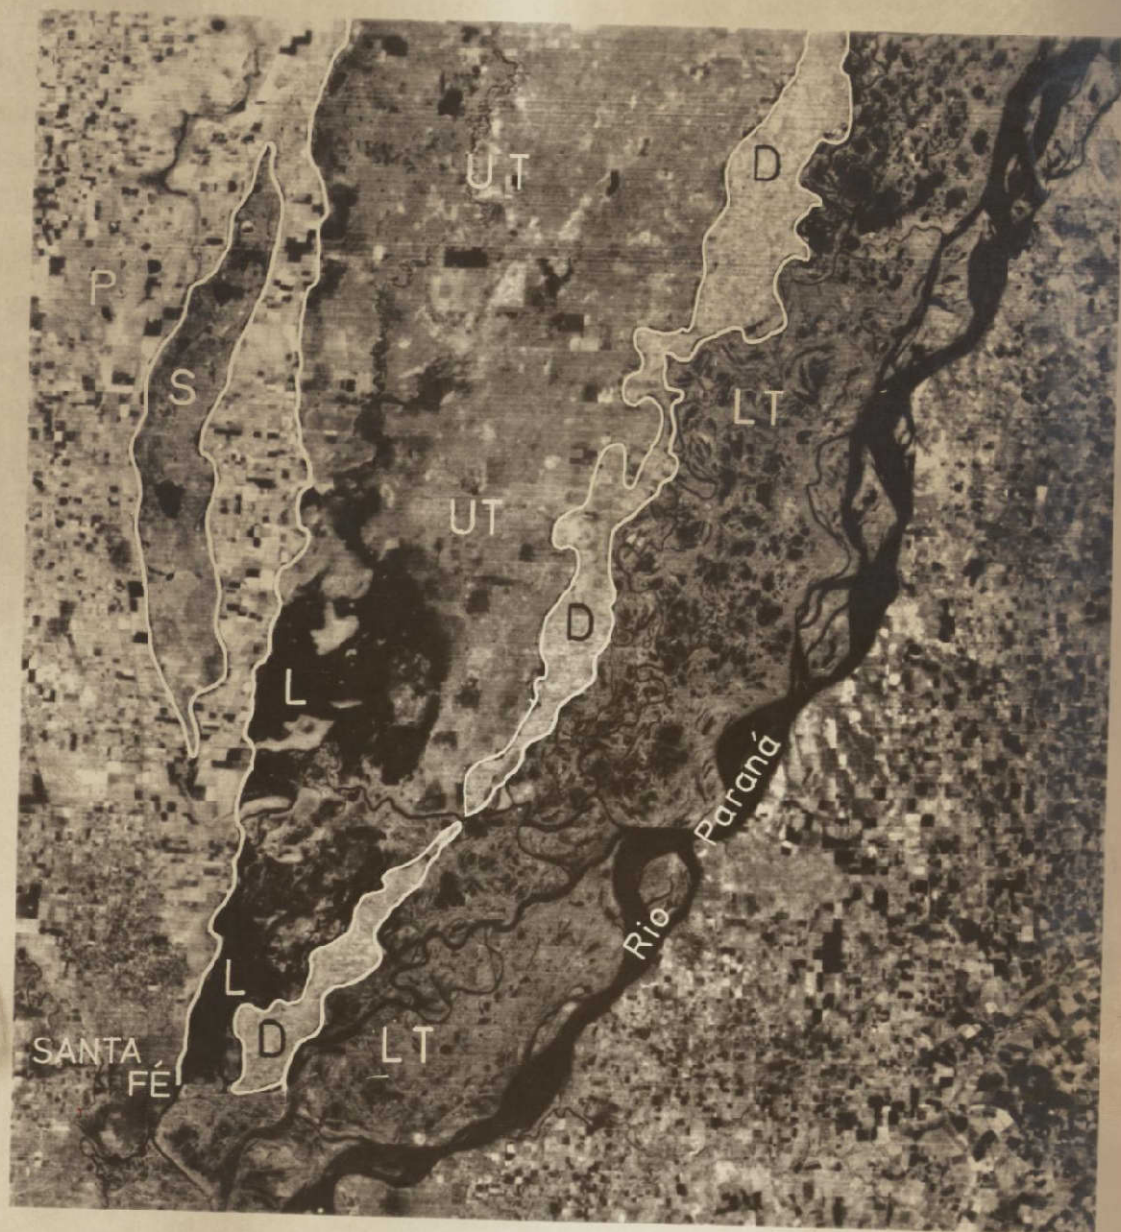
Fig.: 5

Rio Paraná, NE of Santa Fé

- LT Lower Terrace
- UT Upper Terrace
- D Dunes (Upper Terrace)
- S Swamp
- P Pampa Plain
- L Lagoon

On the Eastern edge of the mainly dark colored upper terrace of the Rio Paraná is situated a sand dune field that appears as a white stripe in the imagery (fig. 5).

The depth to ground water in the terrace bed extends to about 1 m, in the sand dunes up to 5 m. The salt content of the ground water differs considerably. In the sand dunes, ground water with a salt content of about 0.3 g/l was found, whereas in the remaining terrace area the salt content exceeds in some cases 6 g/l.

The East of the imaged area is dominated by the Rio Paraná and its terraces. The upper and lower terrace can be distinctly delineated (fig. 5, UT and LT). The lower terrace appears darker than the upper terrace due to a more intense soil moisture. The terraces are partly covered by open waters and meandering streams. Dark grey patches on the image stretching from North to South, to the West of the upper terrace, could be identified as swamp (S in fig. 5). Probably they represent the location of another older terrace.
